Science and Management Technical Series

Experimental Gravel-rolls with Back-sloping and Vegetation Establishment as an Erosion Control Option for Missouri Streambanks

J. Persinger, K. Grmusich, C. Culler, and B. Jamison

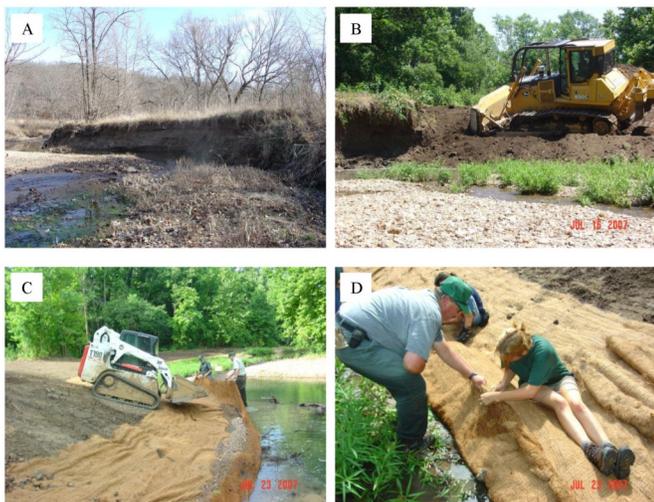
Figure 2. Starks Creek gravel-roll construction. (A) streambank prior to construction. (B) streambank sloping July 2007. (C) Gravel placement July 2007. (D) Sewing the gravel-roll closed July 2007.

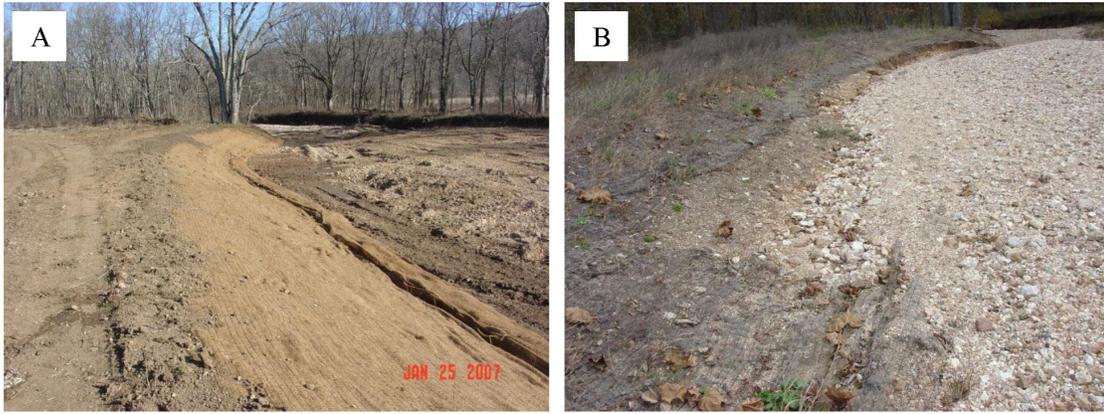
Figure 4. Looking downstream at the Mill Creek gravel-roll project. (A) Post-construction January 2007. (B) Post failure November 2007 showing bed aggradation.

The Mill Creek gravel-roll with back-sloping and vegetation establishment project was built in January of 2007. Mill Creek is a losing stream in the reach where this project was built, so it only has flow immediately following rain events. The first flow event to test the project occurred in September 2007 (Figure 3). During this event, the stream went from no flow to a stage of approximately 5.5 ft. Flows must exceed a stage of 4 ft. to exceed the height of the top of the streambank at this site. The initial flow event caused the complete failure of the project (Figure 4).

The failure occurred because the gravel-roll

functioned as a single long tube and did not adjust to scour in the way that rip rap does. The roll also did not protect a high enough percentage of the streambank so the water scoured the area above and behind the gravel-roll. Once this area started eroding, it con-

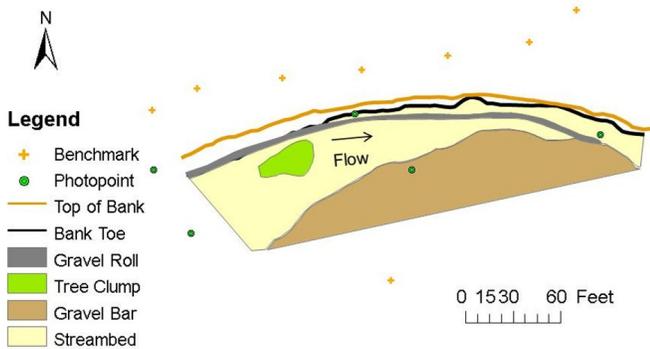
Figure 5. GPS map of Mill Creek gravel-roll project showing gravel-roll location and streambank toe location following project failure in July 2008.

tinued until a large portion of the streambank in the bend was washed away. Even though the streambank eroded severely, the gravel-roll did not come apart or move but rather stayed in place and ended up buried in the streambed. A GPS map showing the location of the gravel-roll and the changes in the channel following project failure demonstrates how the roll stayed in place (Figure 5).

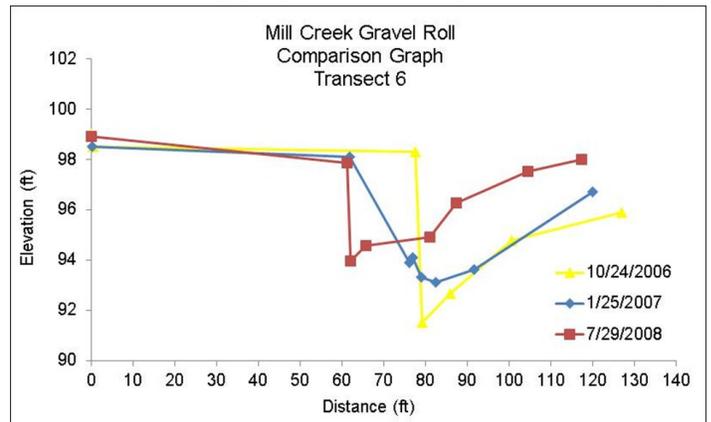
Figure 6. Physical survey data for transect six covering the pre-construction survey (10/24/2006), post-construction survey (1/25/2007), and post failure survey (7/29/2008).

was conducted. Survey data were collected from all seven transects and compared to the survey data collected during the post-construction survey (Table 2). Erosion occurred along all transects, particularly at the downstream end of the project. Erosion resulted in an increase in the slope of the bank. A complicating factor at this site was aggregation of the streambed; the bed actually rose due to aggradation and buried the gravel-roll along the section where failure occurred (Figure 6).

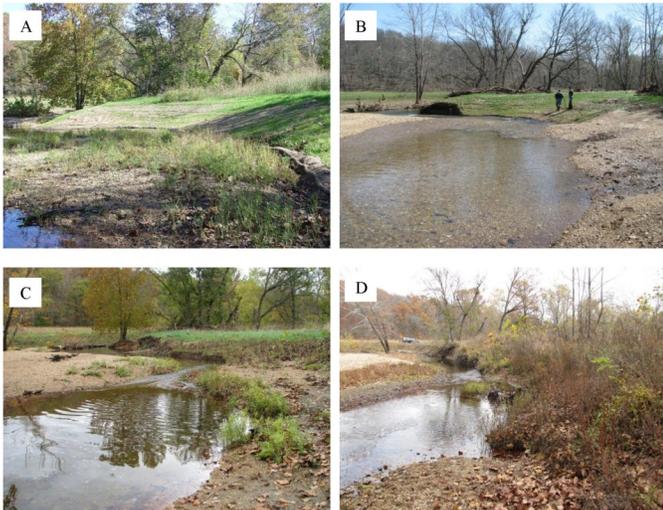
The Starks Creek gravel-roll with back-sloping and vegetation establishment project was built in July of 2007. Following construction, this project was not tested by any high flow events until the spring of 2008. The first two flows greater than $\frac{3}{4}$ of the streambank height occurred in February and March of 2008. The project survived both of these flow events but failed during the first flow event that went over the top of the streambank on March 18th (Figure 7). This flow reached a stage of 12.6 ft., well over the top of the streambank and represented a 10 ft. rise over the average flow the previous week. The flow event caused the complete failure of the project.

Figure 8. Looking downstream at Starks Creek gravel-roll project. (A) Post-construction October 2007. (B) Post failure April 2008. (C) October 2008. (D) October 2011.

The failure occurred for the same reasons as the Mill Creek project. The water scoured the area above and behind the gravel-roll, and once this area started eroding, it continued until a large portion of the streambank in the bend was washed away (Figure 8). Even though the streambank eroded severely, the gravel-roll did not come apart or move but rather stayed in place and ended up buried in the gravel bar that built up on the opposite side of the channel. The gravel-roll was placed at the toe of the streambank during construction. However, following the failure, the gravel-roll was located in the center of the channel due to toe erosion and not because it moved (Figure 9).

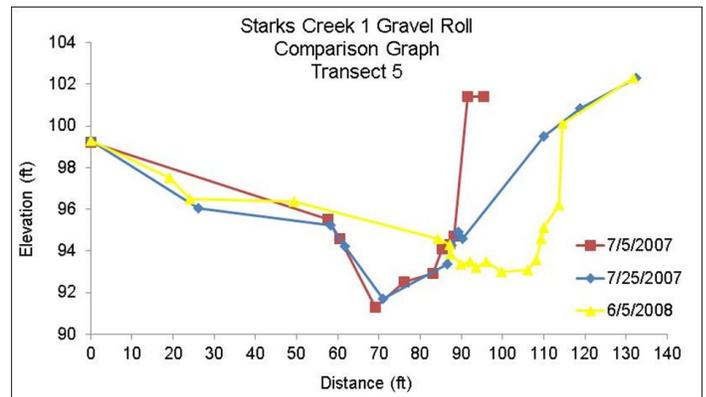
A post-flow survey was conducted in June 2008 and was compared to the survey data collected during the post-construction survey. The data show that in the area where flow is parallel to the project (transects 0-3) the streambank held and maintained its sloped angle. However, the lower end of the project (transects 4-6) failed to protect the toe from erosion and the streambank did not maintain its location or angle. Toe erosion occurred within the final three

Figure 9. Physical survey data for transect five covering the pre-construction survey (7/5/2007), post-construction survey (7/25/2007), and post failure survey (6/5/2008).
