Science and Management Technical Series

Experimental Gravel-rolls with Back-sloping and Vegetation Establishment as an Erosion Control Option for Missouri Streambanks

J. Persinger, K. Grmusich, C. Culler, and B. Jamison

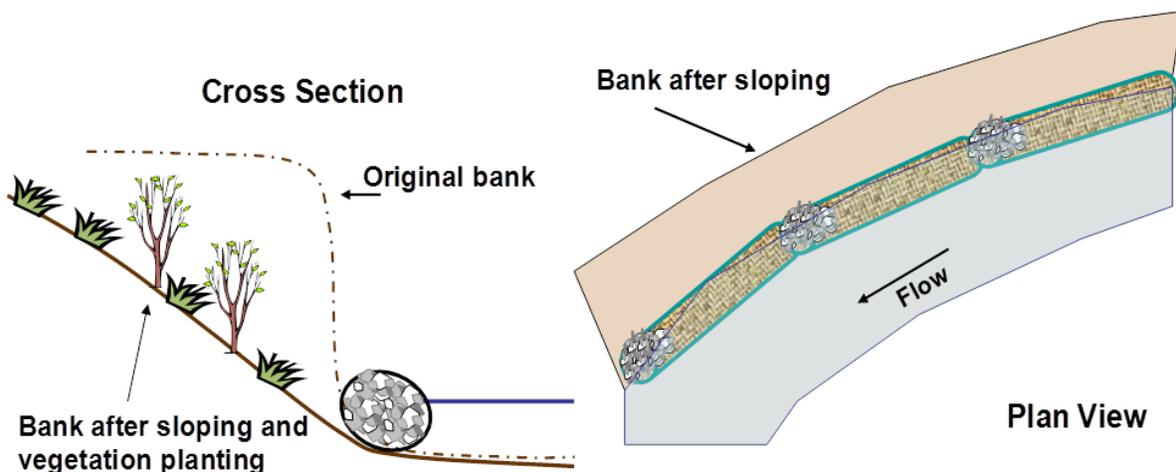
Figure 1. Cross sectional and plan view of a back-sloped streambank with a gravel-roll.

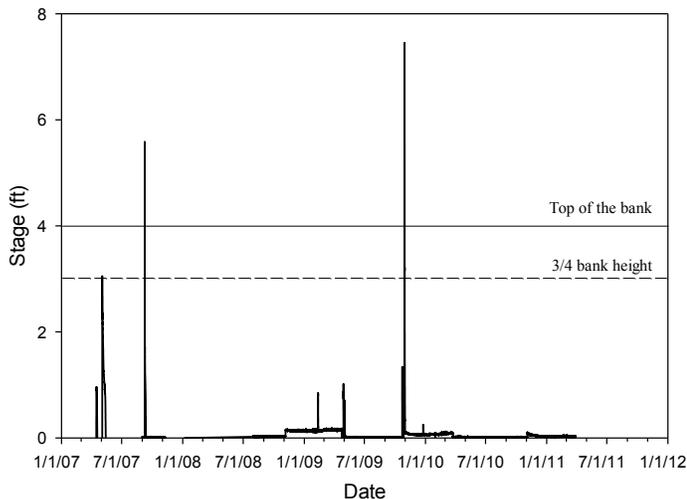
Figure 3. Levellogger® data from Mill Creek for January 2007 through March 2011. Flow data are missing for the period from 11/8/2007 through 7/30/2008 and after 3/28/2011 due to the loss of multiple Levellogger®s during high flow events.

The Mill Creek gravel-roll with back-sloping and vegetation establishment project was built in January of 2007. Mill Creek is a losing stream in the reach where this project was built, so it only has flow immediately following rain events. The first flow event to test the project occurred in September 2007 (Figure 3). During this event, the stream went from no flow to a stage of approximately 5.5 ft. Flows must exceed a stage of 4 ft. to exceed the height of the top of the streambank at this site. The initial flow event caused the complete failure of the project (Figure 4).

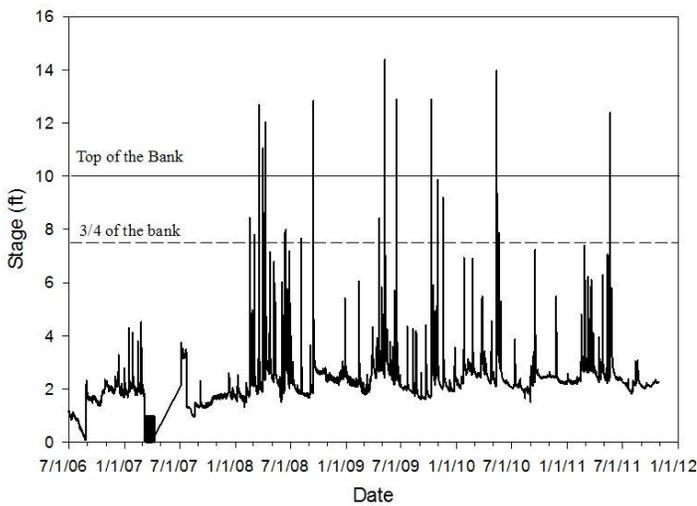
The Starks Creek gravel-roll with back-sloping and vegetation establishment project was built in July of 2007. Following construction, this project was not tested by any high flow events until the spring of 2008. The first two flows greater than $\frac{3}{4}$ of the streambank height occurred in February and March of 2008. The project survived both of these flow events but failed during the first flow event that went over the top of the streambank on March 18th (Figure 7). This flow reached a stage of 12.6 ft., well over the top of the streambank and represented a 10 ft. rise over the average flow the previous week. The flow event caused the complete failure of the project.

Figure 7. Levellogger® data from Starks Creek for June 2006 through October 2011. Flow data are missing for the period from 3/6/2007 through 7/5/2007 due to a Levellogger® malfunction.
